Technical Bulletin

Subject: **Wiring Harness, Repairing**

Number: **98-03**

Date: **July 24, 1998**

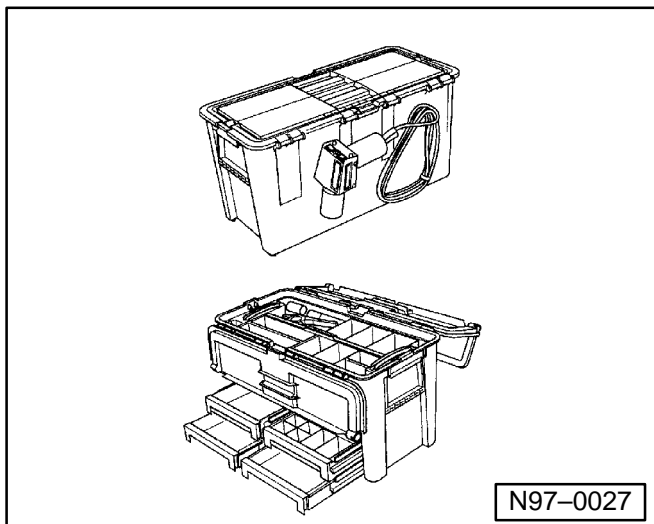
◀ The VAS 1978 wiring harness repair kit was developed as a tool for wiring harness repairs.

All approved materials and a repair guide are supplied in the repair kit, including approved closed barrel butt splice connectors with thermoplastic material inside and shrink tubing outside, specified for 3 defined wire gage ranges that are color coded (red, blue, yellow).

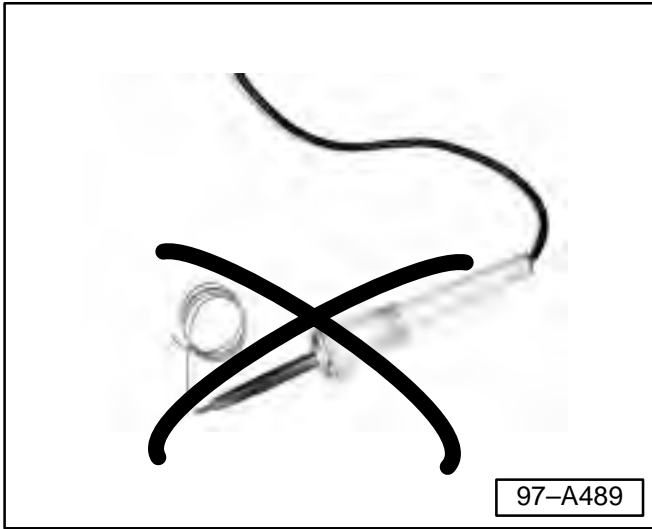
◀ Soldering is specifically omitted from VAS 1978 repair instructions due to:

- Questionable quality and reliability of soldered joints.
- Potential for consequential damage at soldered joints (due to hot soldering iron in close proximity to other components and wiring).

- Safety hazards posed by a “spark gap” condition at soldered joints, when two very large gage wires are “soldered” together. The heat generated could be sufficient to cause the insulation to melt or flame, and there is a potential for personal injury caused by molten solder.

- Latent “Broken Wire” defect near soldered joints, where a wire separates under the insulation due to corrosion and/or fatigue, caused by overheating wire strands during the soldering process. Overheating promotes wire embrittlement, wire strand fatigue, and corrosion.

- Technical inferiority of a soldered joint, where wires are “stuck” together, versus a crimped or welded joint, where the wires are fused together. There is only minimal contact between wires in a soldered joint, where the main transmission path is through the solder (increased resistance). When properly accomplished, crimping reduces the nominal cross-section of a wire by about 20%. Although there is some small resistance, transmission is essentially unimpeded across a crimped joint.

- 1 - Always use the VAS 1978 Wire Harness Repair Kit .
- 2 - If the wire harness cannot be repaired using the procedure and materials contained in VAS 1978, then the wire harness must be replaced.
- 3 - No other procedure or materials, other than those in VAS 1978, may be used for wire harness repairs, specifically soldering, wire nuts, generic repair kits, etc.

DO NOT use solder when repairing a wiring harness.
