SUBJECT: Campaign #84 - Rialta® Wheel Cover

Replacement of Wheel Covers on 2002 Kia Ista models

(Limited number of vehicles built from February 1, 2001 to June 22, 2001)

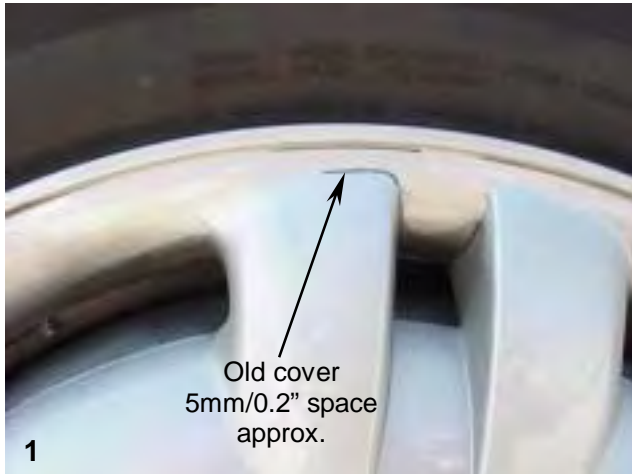
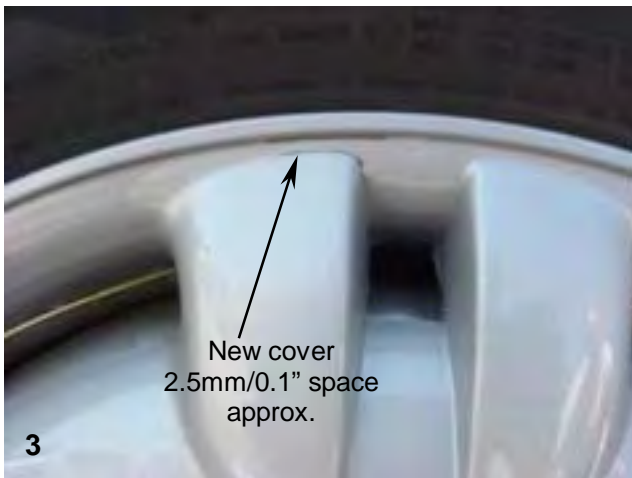
Existing wheel covers on these vehicles may rotate and cause damage to valve stems. Also, some front wheels may be equipped with rubber-mounted brass valve stems instead of rigid-mounted silver steel ones.

As you can see in photos 1 and 3, the space between the spoke tip and perimeter bead is greater on the old wheel cover than the new one. In photos 2 and 4, you will note that the old wheel covers have a larger diameter (17.7") than the new wheel covers (17.4").

1. **Replace three (3) rubber-mounted brass valve stems** on both rear wheels and the spare tire with new rigid-mounted steel valve stems and extensions supplied in parts kit.
 - **Tighten the valve stem retainer collars to 4.4-5.9 ft./lbs.**
 - **Tighten the wheel lug bolts to 105-128 ft./lbs.**
2. **Inspect the front wheel valve stems** to verify that they are rigid-mounted steel valve stems. (If any wheel on the vehicle is equipped with a rubber-mounted brass valve stem, it must be replaced with a rigid-mounted steel one.)
3. **Replace all four (4) wheel covers** with new covers supplied in parts kit.
4. **Retain all parts for SDM scrapping.** (Failure to submit replaced parts for scrapping may interfere with warranty labor recovery and may be subject to federal penalties.)
