Service Campaign

AFFECTED: 2004 Rialta, Vista, and Sunstar

DATE: November 7, 2003

SUBJECT: Rear Wheel Well Reinforcement

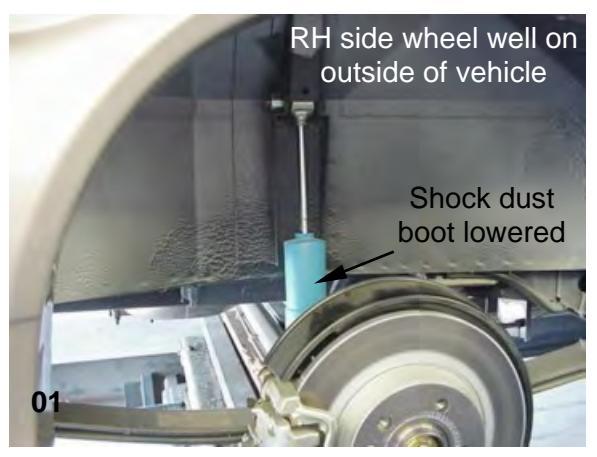
- Slide the shock absorber dust boot down as shown in <u>photo 01</u> to avoid damage to the boot. Then wrap the shaft with a removable protective masking material to avoid damage to the shock.
- 3. Use the two 4" x 12" pieces of 22-gauge sheet metal supplied as shields to avoid penetration by drill bits of wires and hoses inside of the vehicle.
- Bend the RH (passenger side) shield to hold the wires away from the inner wheel well surface as shown in <u>photo 02</u> and be sure the bottom edge of the shield touches the floor.

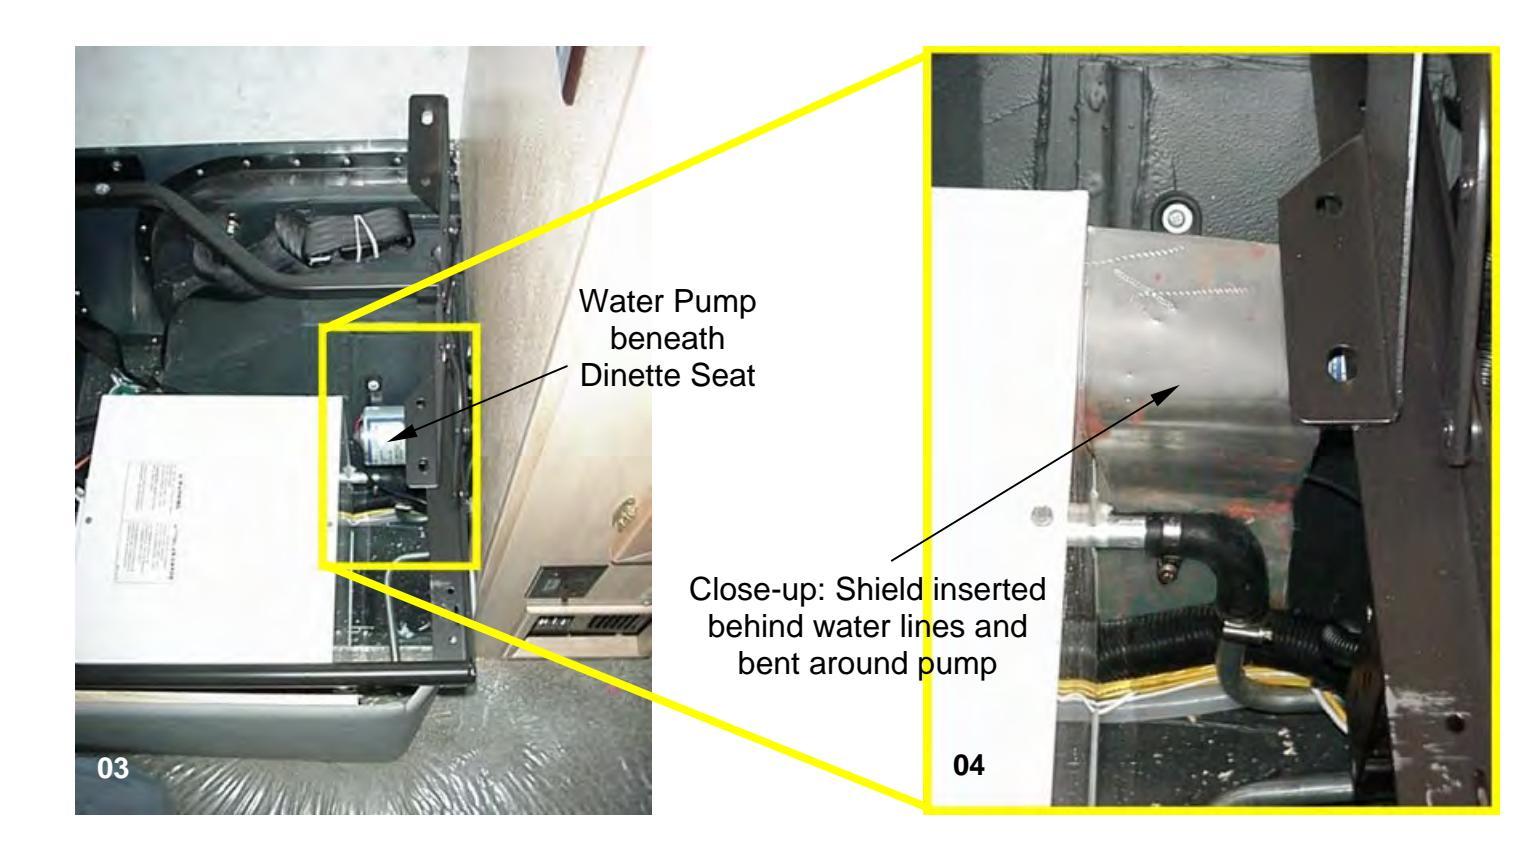
5. Slide the LH (driver side) shield down between wires and wheel well, then bend it around the water pump as shown in *photo 03* and *close-up 04*.

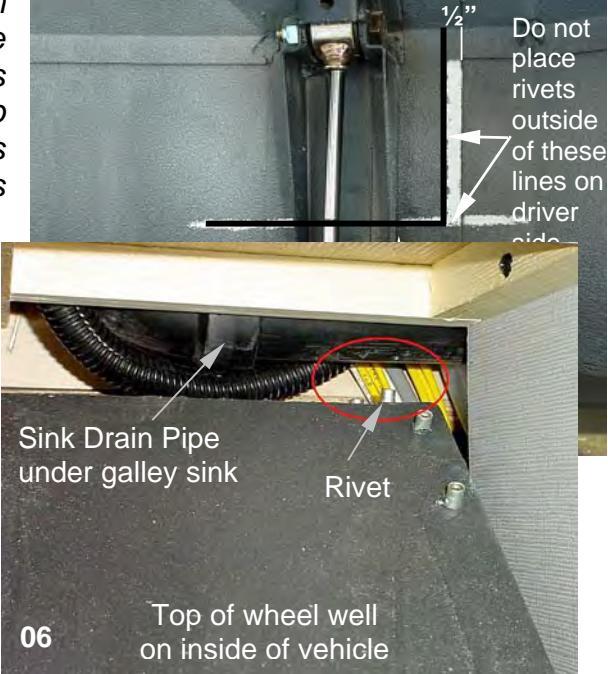
Driver Side: Measure 4½" up from the bottom edge of the wheel well and ½" forward from the rear edge of the shock mount backing plate as indicated by white paint lines in <u>photo 05</u>. Keep all drilled holes above and forward of these lines to avoid hitting motor aid water heater lines directly behind the wheel well.

CAUTION: Drilling below or aft of the indicated lines may cause coolant leaks in water heater motor aid lines which could lead to engine overheating or failure.

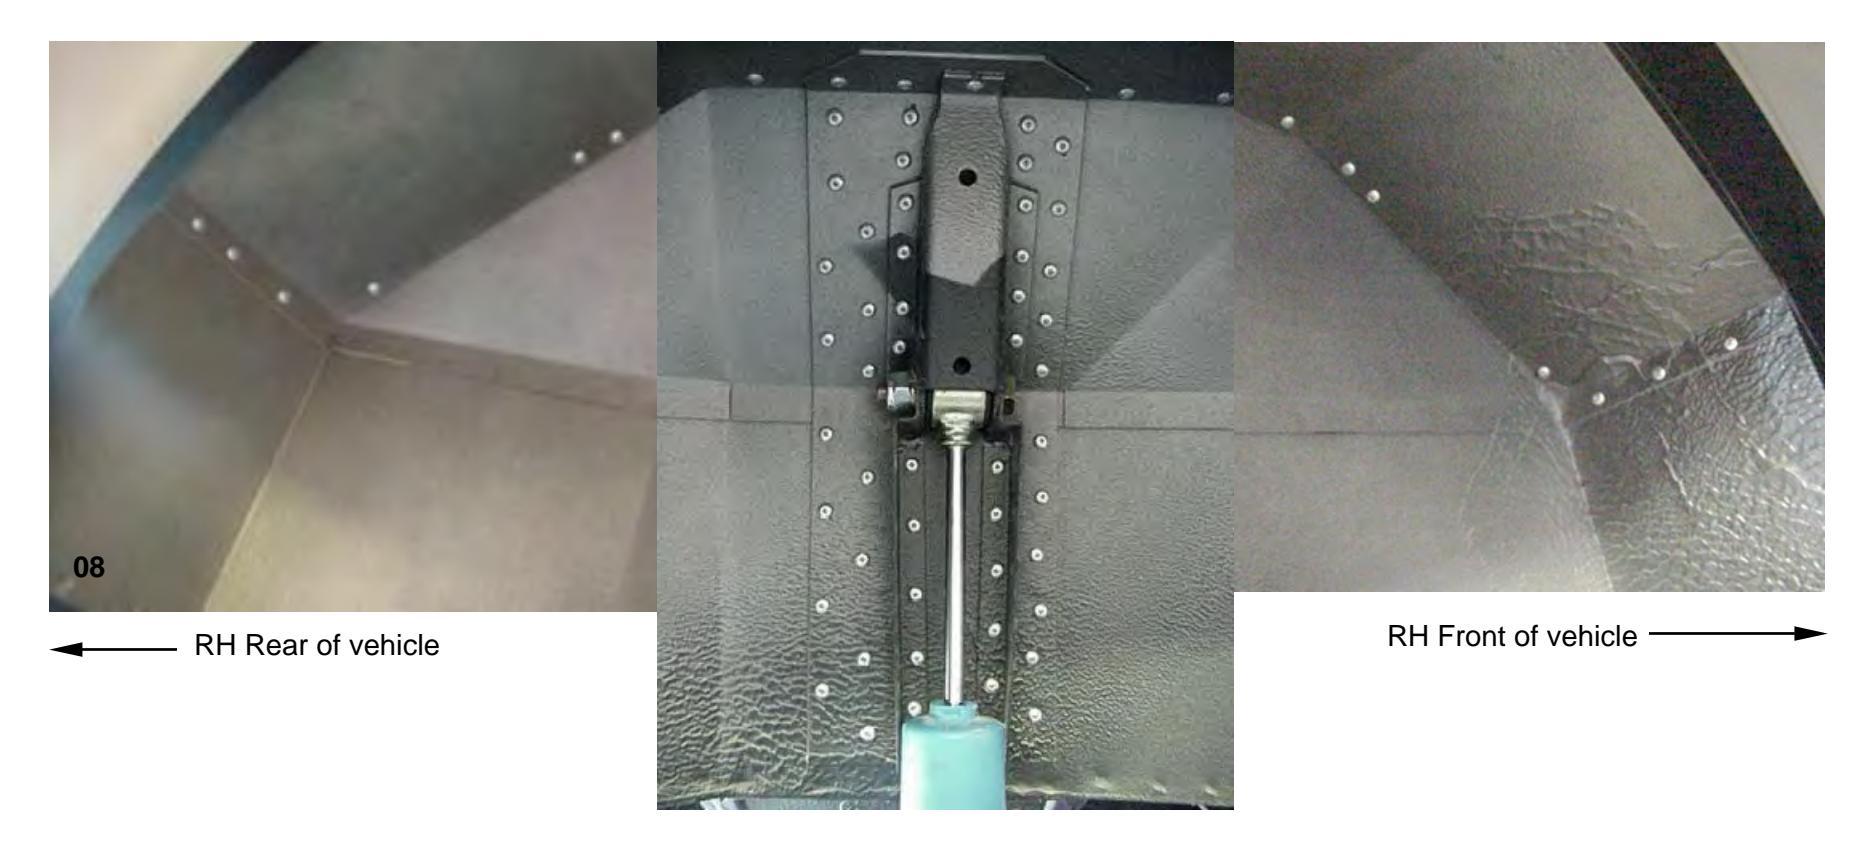
RH rear wheel well shown with tire removed and shock dust boot lowered. Use all 67 rivets allocated per side to maintain equal shear strength.
 LH side: Repeat pattern in mirror image except for lower 4½". Add remaining rivets equally between other rivets on shock mount area (See photo 05 and Caution in step 6)

6. After shields are in place, begin drilling **1/8**" **pilot holes** through wheel well areas as shown in <u>photo 07</u> on the following page (67 holes per side). Since this procedure is intended merely to reinforce existing spot welds, position of holes are approximate only.

- Enlarge pilot holes with a 13/64" bit* to allow 3/16" rivets.
 *Note: You can use a common 3/16" bit if you wish, however we found the extra 1/64" clearance of the 13/64" bit made rivet insertion much easier and quicker.
- 8. Clean any undercoating or paint around the holes as shown in photo 07.
- Install 3/16" steel monobolt rivets p/n 087718-01-000 (67 per wheel well- supplied) as shown in <u>photo 08</u> on the following page.
- 10. Apply undercoating over the rivets to ensure a complete seal from air, dust or moisture entering the coach.
- 11. Remove masking material from the shaft and upper shock mount shock and secure the dust boot back up into place at the top of the shaft. Remove the metal shields.
- 12. Install rear wheels and torque lug bolts to 130 ft. lbs. (min. 120 140 max.)
