Dealer Service Bulletin

NO.: 7SB001-02-01A

AFFECTED: 1995-2000 Rialta motor homes

SUBJECT: VW Eurovan Chassis Oil Filter Access Improvement

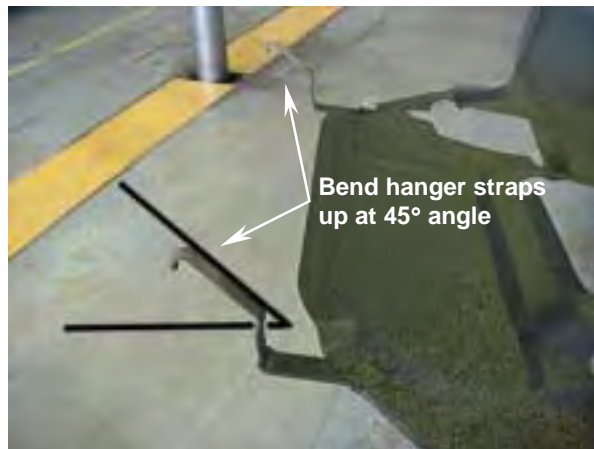
The belly pan attachment hinges (hangers) may be modified by bending as shown. This modification allows removal of the swing-down type belly pan by simply jacking the front end slightly, without having to raise the vehicle on a hoist.

- Remove belly pan from vehicle and place bottom-side-down on floor or bench.
- Use pliers or other gripping tool to change the angle of both attachment hangers to 45° as shown on template at end of bulletin.
- Reinstall belly pan.
