DIY Eurovan Door Handle Repair (2003 EV MV)

So this DIY fix is for all of you who don't have the \$100 to throw at a new door handle when the internal metal L-bracket pivot shears off. This will require some drilling (and maybe a tap) - but at this point why not try - otherwise the old door handle is just an expensive paper weight.

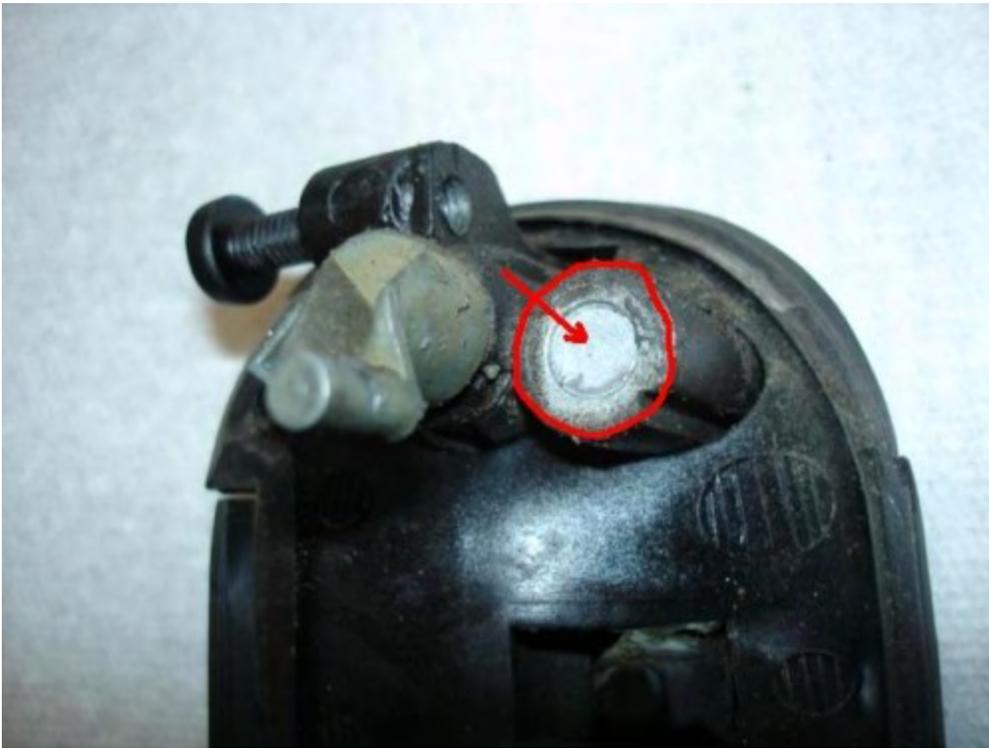
1. Take out the door handle by removing the two screws just on the inside of the door. Remove the rubber gasket surrounding the back of the entire handle and hopefully the broken parts (L-bracket) are still there.
