Replacing the Foam on the A/C Diverter Flaps Without Removing the Entire Dash

Summary file of repairing the dash flap – various sources and ideas

Repairing Dash Heater/AC Vent

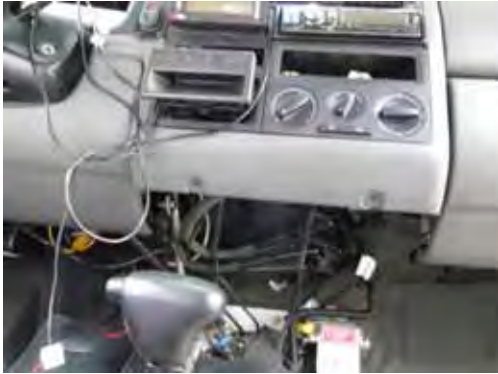
Picture 1

2. Remove the plastic "junk" tray that rests on the floor in front of the gear selector and the panel under the radio (Picture 1).
3. You will need to cut through the plastic to access the diverter flaps. When you lie on your back and look up under the dash, you will see where to cut. A headlight strapped to your head works well for this task. A sharp utility knife will work, but a better tool might be the oscillating multi-tool (available at Harbor Freight for about \$20) The hole will need to be large enough to get your hand inside to tape/glue the new cover over the flaps. (Picture 2)

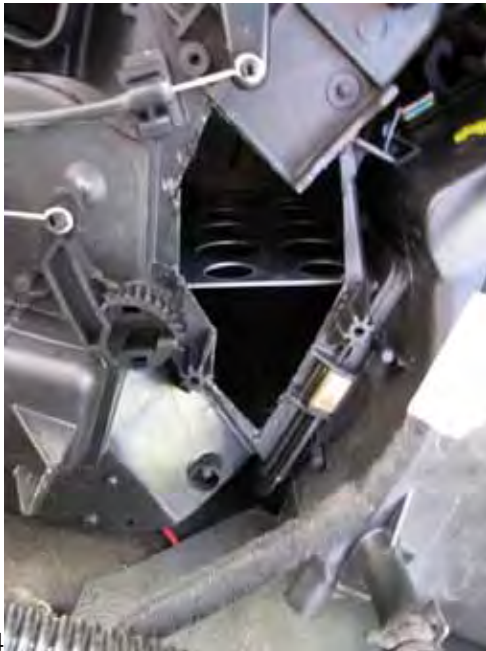
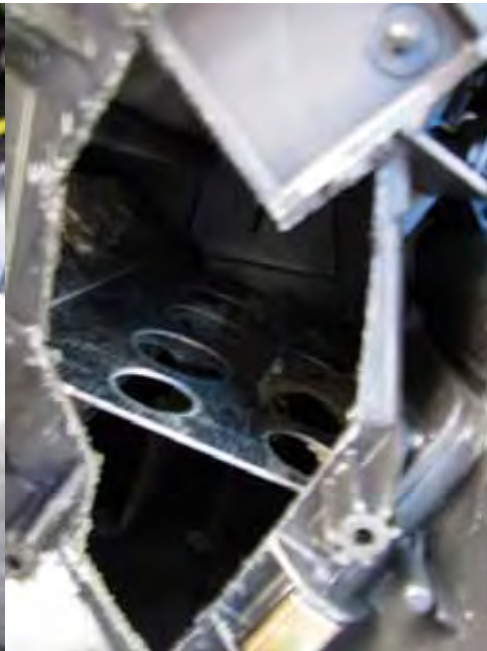
Pictures 3 & 4

4. Remove the buttons that change from heat to A/C to see the diverter flaps and what needs to be repaired. Once the piece is out you can look up and turn your dash dials and see the metal pieces move from air to heat. (Pictures 3 & 4)

5. If needed, remove the rest of the old foam with tweezers or whatever tool will fit in the space. You can also blow out the foam debris. The first flap has holes in it and the second flap is solid and farther up into the interior.

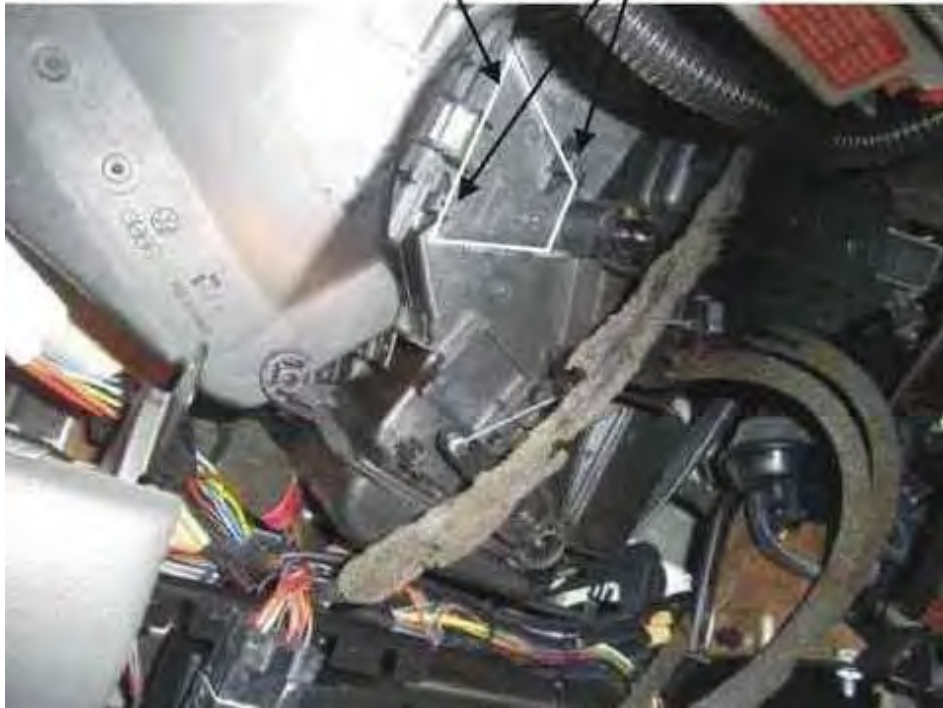
Cut area out

Cut tabs off

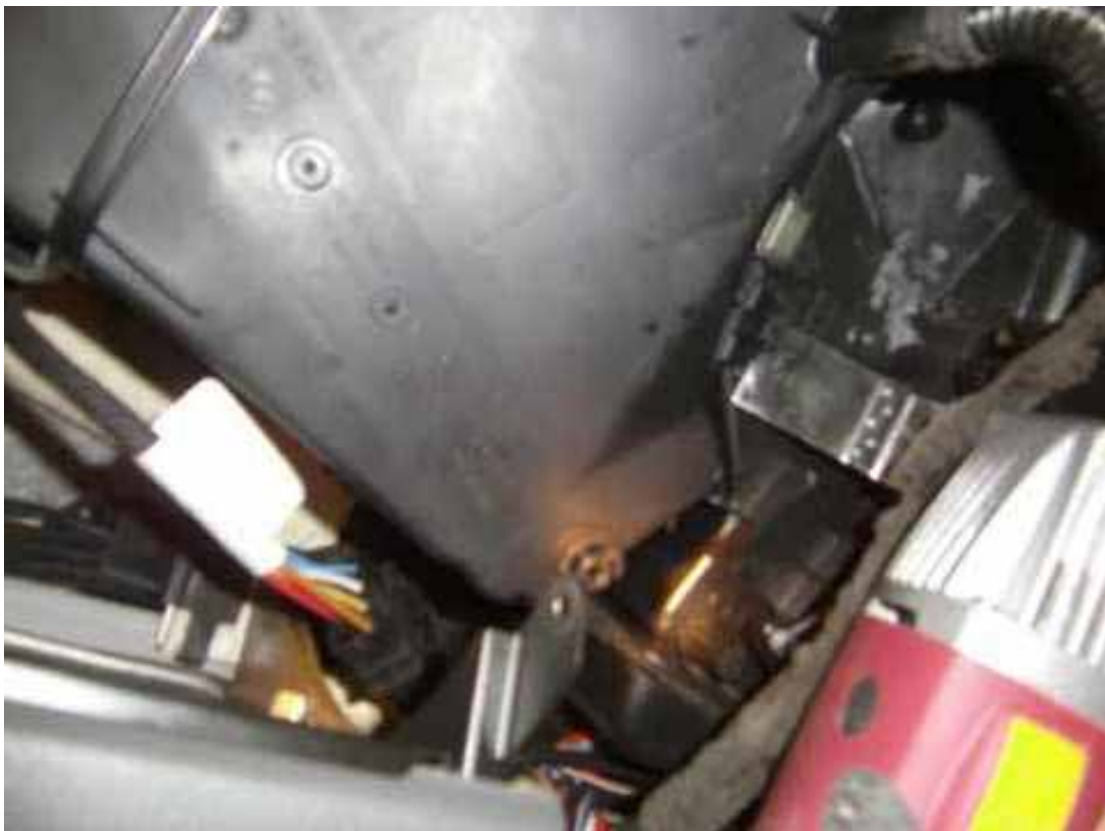
Showing tool in position

Procedure: I used the Gerry tape method. As advised, I removed the passenger seat for better access. I wore my head-mounted light so I could see under the dash. I removed the lower parts of the dash containing the footwell duct, the cupholder and the storage recess. From Harbor Freight, I got a Chicago Electric Oscillating Multifunction Power tool with a one-inch wood/plastic saw blade. From a crafts store I got a Sharpie Paint pen in white. Using a three-inch spackling blade as a straightedge, I outlined the cutlines from Gerry's pictures. I used the photos from ev_update@yahoo.com 93 EV GL AC/Heater as guide. Orienting the photo so that the writing is on the bottom margin and the colored wire bundle is at the top makes it easier to see the layout. Once I made the cut I determined that the opening could have safely been made larger. (See my modification of the [ev_update](mailto:ev_update@yahoo.com) photo.) I made a second cut which made it relatively easy to get my hand in to place the tape on both sides of the flap. I creased the tape lengthwise to give it some rigidity, pulled away the backing to reveal the "sticky" on one end, placed the sticky end on the flap. With the tape then held in place, I removed the rest of the backing, pressing down on the tape. (Replacing two cut out pieces made closing the opening more difficult.) I suggest cutting the larger opening.

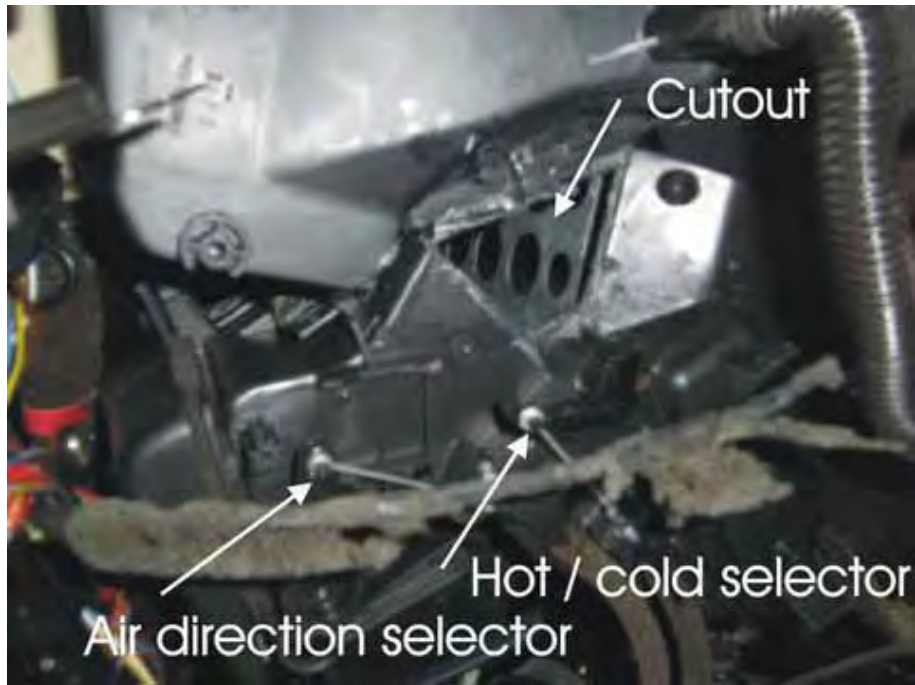
View with hole cut

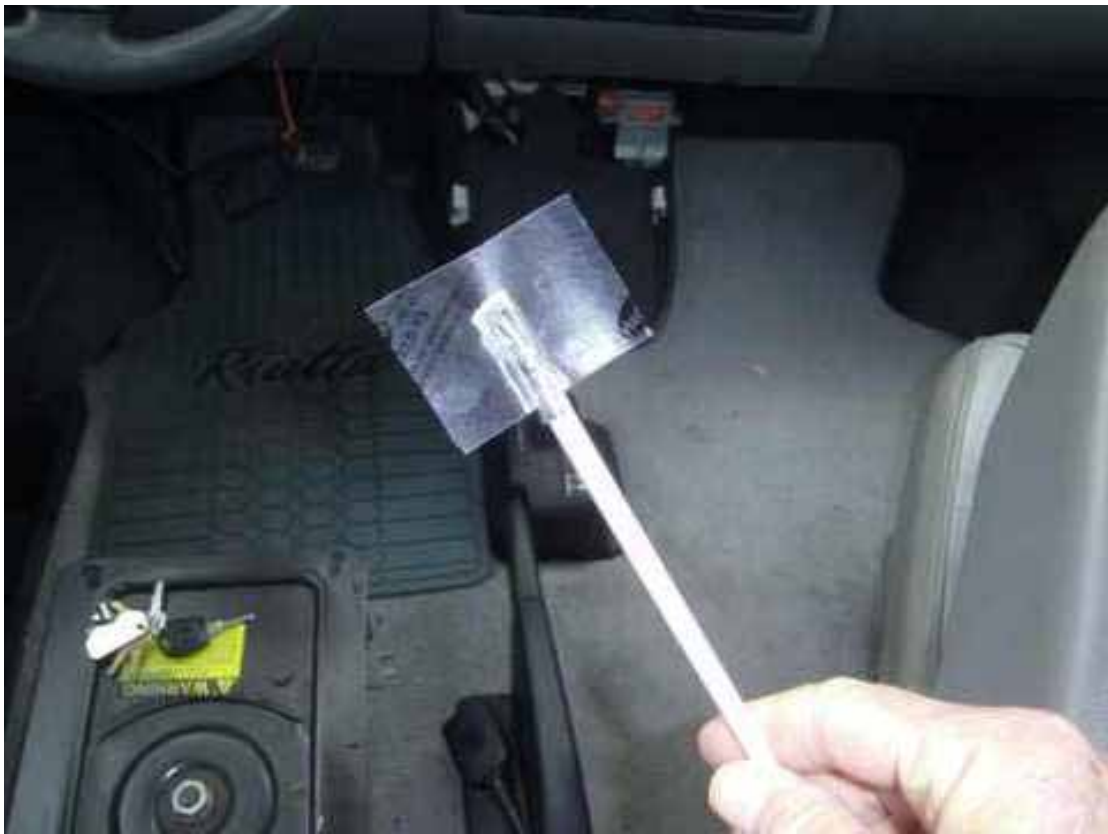
Tape ready to install

I used seven-inch pieces of HVAC Shurtape AF 100 181A-P/181B-FX on both sides of the cold/hot flap exposed by the cut and on both sides of the ventilation direction flap easily accessible with the lower dash removed. After testing the operation of the repaired flaps, I glued the removed pieces back into the heater box with PVC pipe cement and sealed with a bead of the Burt-recommended Dollar Store Fix-All Adhesive The Original Super Glue. (I also put a piece of the aluminum tape over the repair.)
