Replacing the Foam on the A/C Diverter Flaps Without Removing the Entire Dash

Summary file of repairing the dash flap – various sources and ideas

Repairing Dash Heater/AC Vent

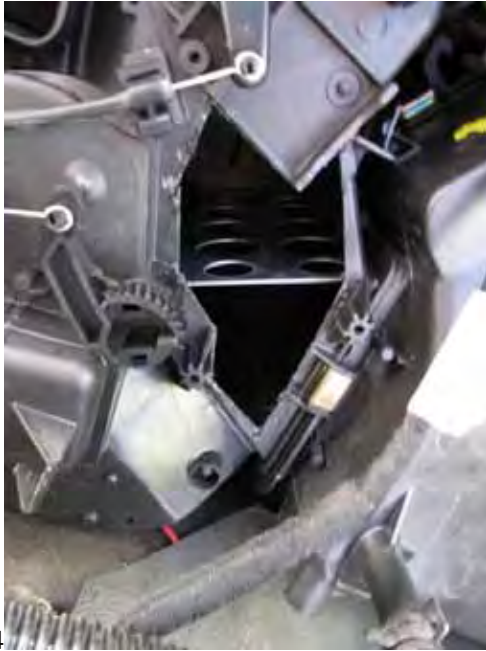
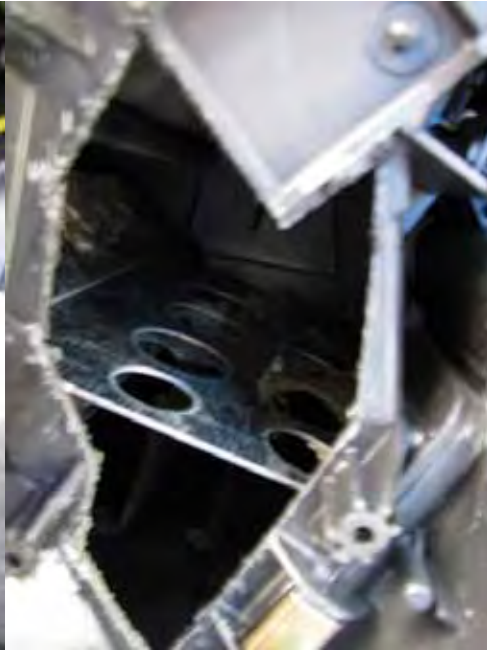
Pictures 3 & 4

4. Remove the buttons that change from heat to A/C to see the diverter flaps and what needs to be repaired. Once the piece is out you can look up and turn your dash dials and see the metal pieces move from air to heat. (Pictures 3 & 4)

5. If needed, remove the rest of the old foam with tweezers or whatever tool will fit in the space. You can also blow out the foam debris. The first flap has holes in it and the second flap is solid and farther up into the interior.

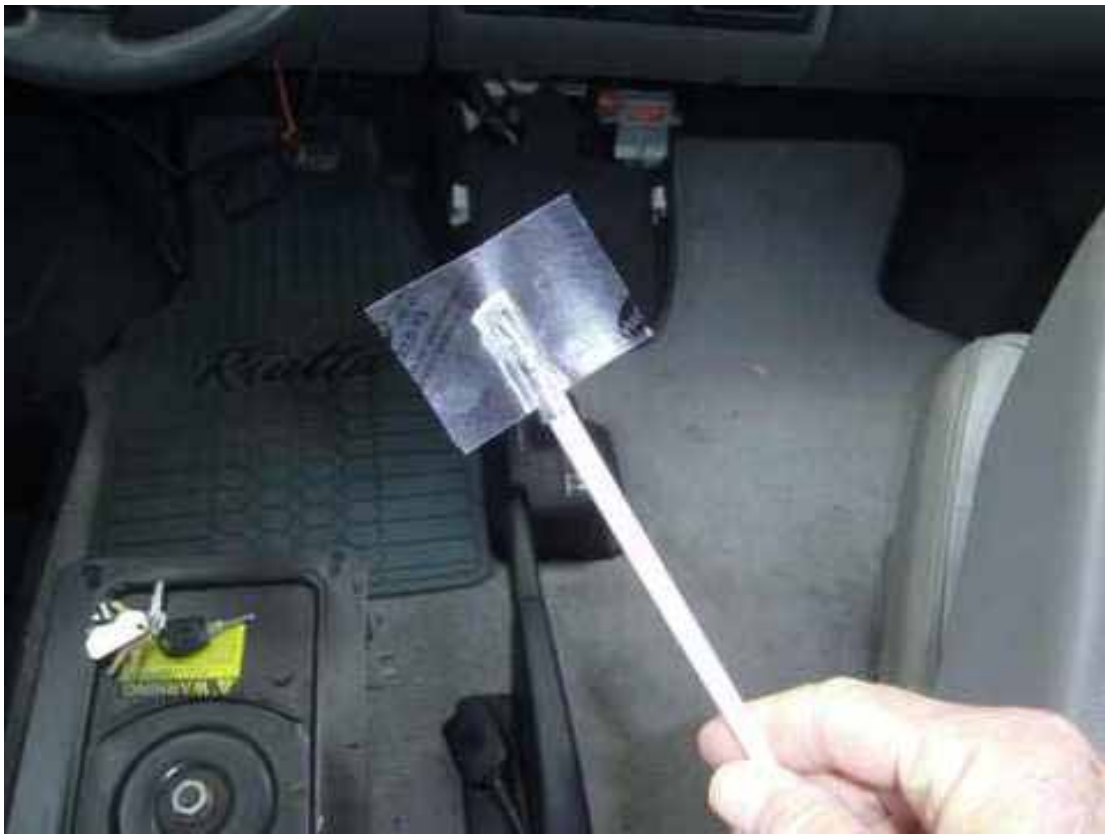
Tape ready to install

I used seven-inch pieces of HVAC Shurtape AF 100 181A-P/181B-FX on both sides of the cold/hot flap exposed by the cut and on both sides of the ventilation direction flap easily accessible with the lower dash removed. After testing the operation of the repaired flaps, I glued the removed pieces back into the heater box with PVC pipe cement and sealed with a bead of the Burt-recommended Dollar Store Fix-All Adhesive The Original Super Glue. (I also put a piece of the aluminum tape over the repair.)
