WIRING INSTL-EXTERIOR LAMPS

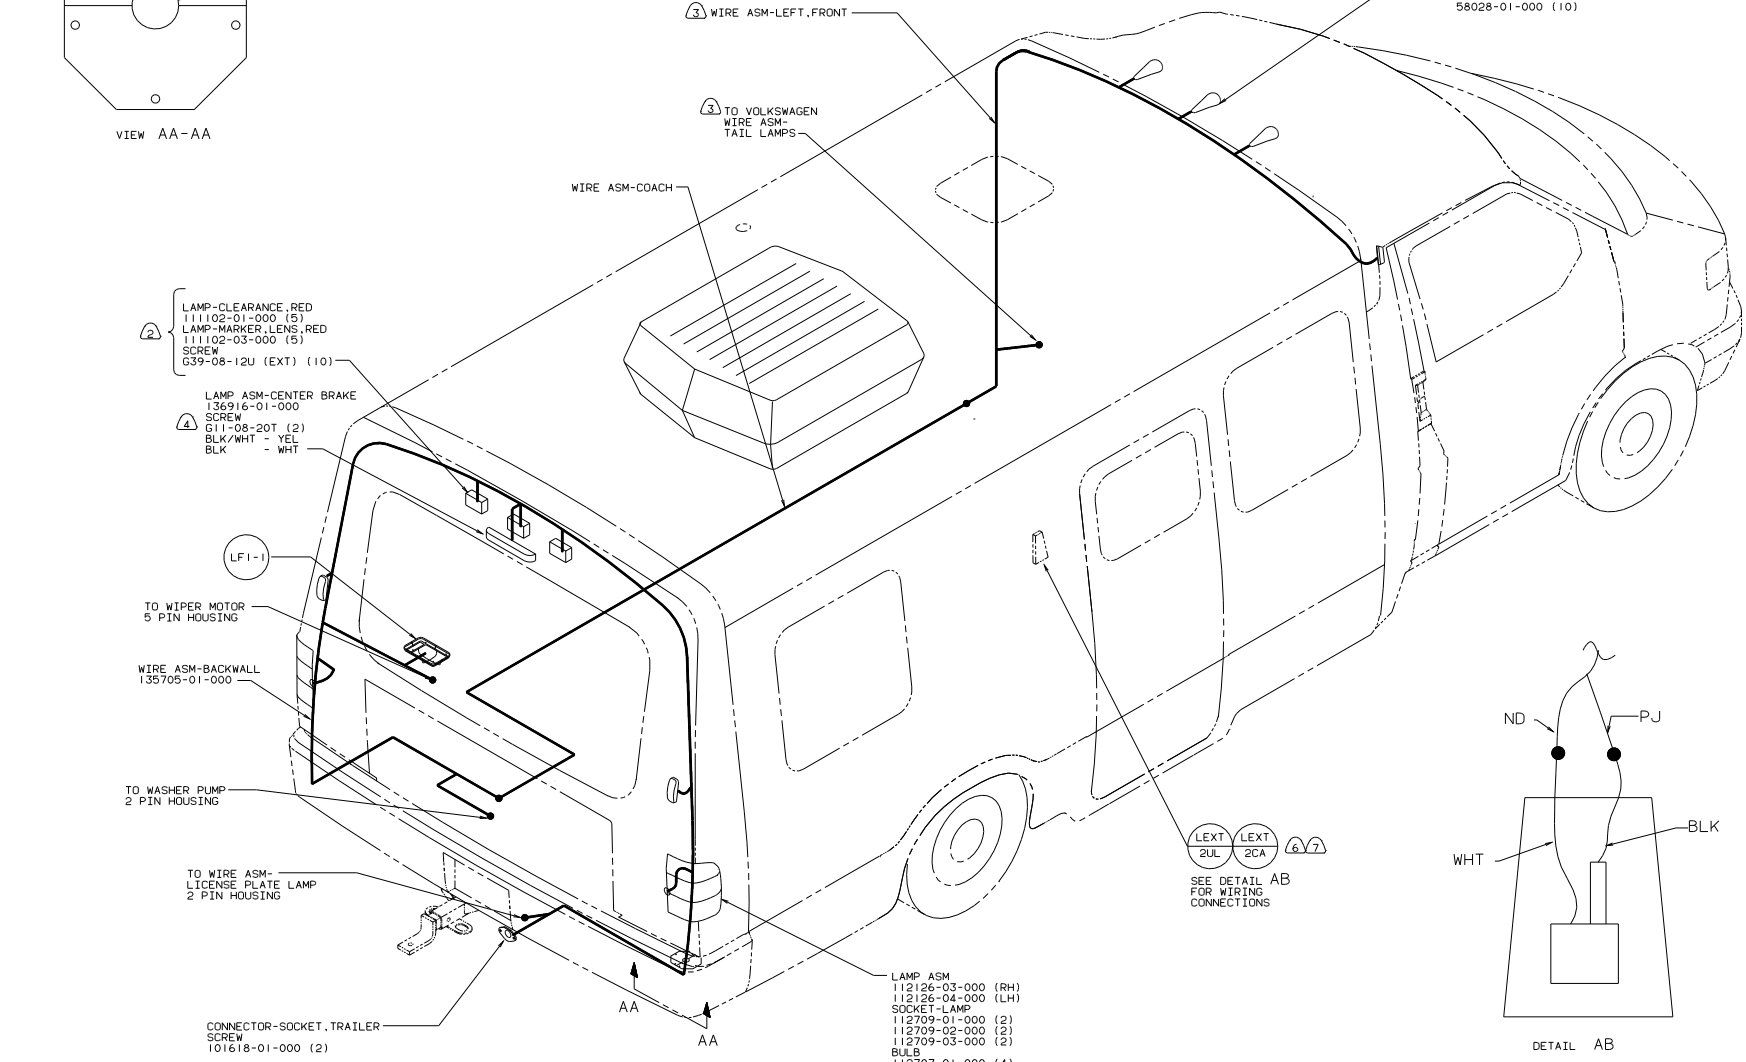
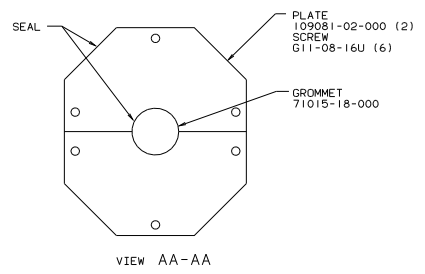
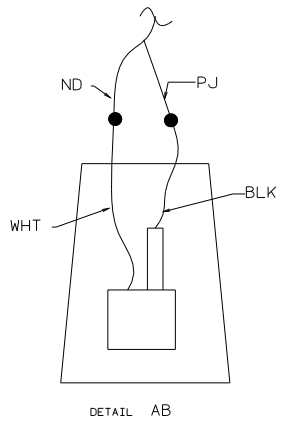
LEX 2UL LEX 2CA
 SEE DETAIL AB FOR WIRING CONNECTIONS

- LAMP ASM
- 112126-03-000 (RH)
- 112126-04-000 (LH)
- SOCKET-LAMP
- 112709-01-000 (2)
- 112709-02-000 (2)
- 112709-03-000 (2)
- BULB
- 112707-01-000 (4)
- 112708-01-000 (2)
- BRACKET ASM-TAIL LAMP
- 113778-03-000 (2)
- SCREW
- G39-10-209 (4)
- GROMMET
- 23942-01-000 (2)

- ⑦ INSTALL WITH WIRE TOWARD ROOF.
 - ⑥ NOT USED ON THE 222S.
 - ⑤ CONNECT WIRE HX (YEL) TO RED WIRE AND WIRE MS (WHT) TO WHT WIRE.
 - ④ ON INTERIOR OF CAP, GRIND OFF TIP OF SCREW PRIOR TO SEALING (TO PROVIDE INNER LINER CLEARANCE).
 - ③ SEE WIRING INSTL-FRONT END FOR ADDITIONAL INFORMATION.
 - ② LOCATE ON CENTER OF HOLE IN CAP REAR.
1. CONNECTOR-PLUG, TRAILER 113589-01-000 TO BE SUPPLIED LOOSE IN COACH WITH TRAILER TOW PACKAGE.
