(CAN 110V WIRING)

OF IN		DATE	UNDESIGNED TOLERANCES ARE	MATERIAL
CHP	DATE	ONE-PLACE (19, 21)		
PIE	DATE	TWO-PLACE (19, 21)		
D/E	DATE	ANGLE		
CONP	DATE	INDIC. W/ANGLE PROJECTION		
LAYOUT NO.		TITLE		98 222RC
REV #		SCALE	NOTE	WIRING DIAGRAM-BODY 110V
ALL DIMENSIONS ARE IN MILLIMETERS		SHEET	1 OF 1	126970

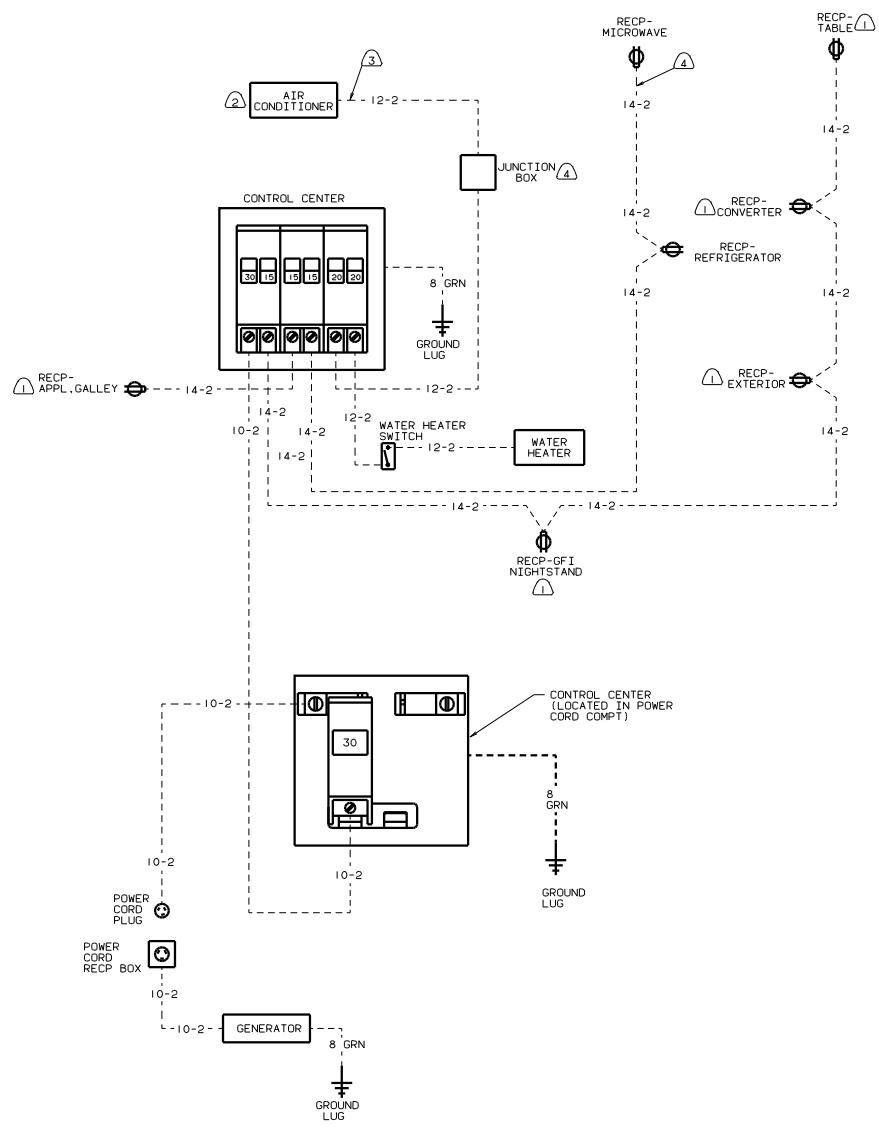
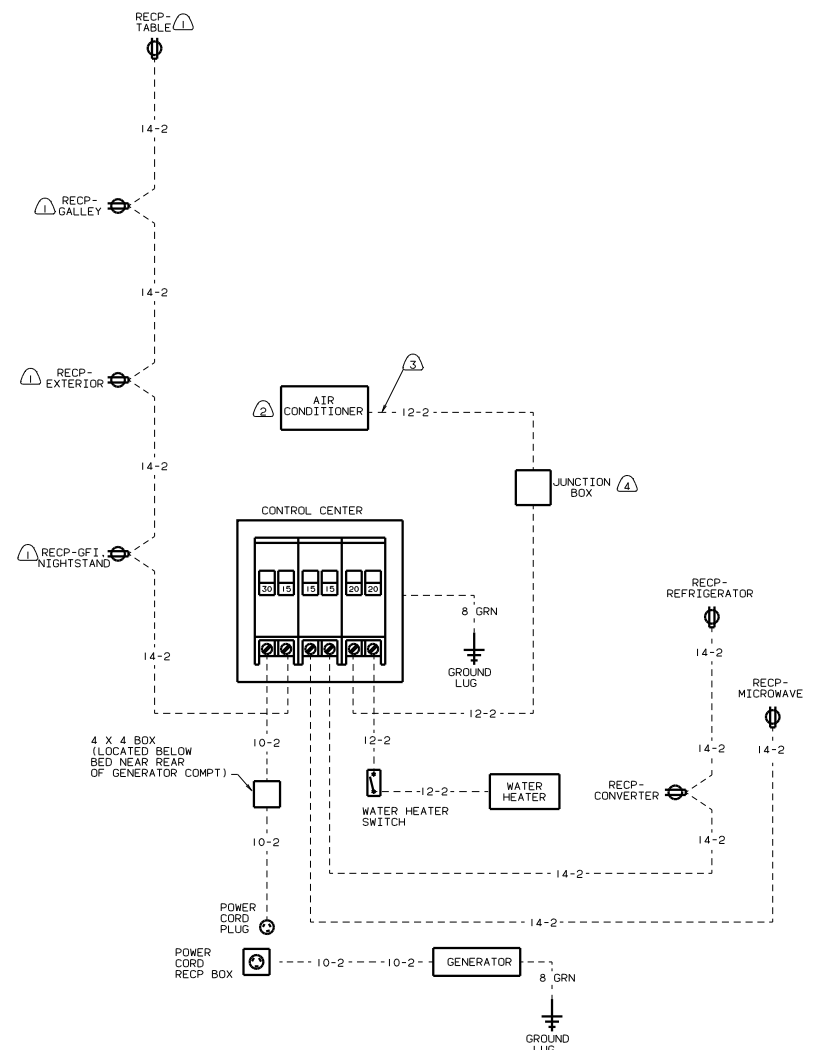
- (4) NOT USED WITH 29K A/C. ROOF TWO 13,500.
- (3) WIRE ROUTED THRU ROOF.
- (2) WITH AIR CONDITIONER.
- (1) PROTECTED BY GFI RECP.
