WIRING DIAGRAM COACH (WIRE ASM 141381)

COPYRIGHT 2002 WINNEBAGO INDUSTRIES, INC.		03 222HD	
DTR	DATE	UNSPECIFIED TOLERANCES ARE:	MATERIAL:
CHR	DATE	ANGLE DIM (X.X)	+
P E	DATE	ONE-PLACE (X.X)	+
M E	DATE	TWO-PLACE (X.XX)	+
DNR	DATE	ANGLE	+
	DATE	THIRD ANGLE PROJECTION	
LAYOUT NO	TITLE	WIRING DIAGRAM-BODY, 12V	
DIA #	SCALE	DO NOT SCALE DRAWING	SIZE
		SHEET 1 OF 2	NO 141384

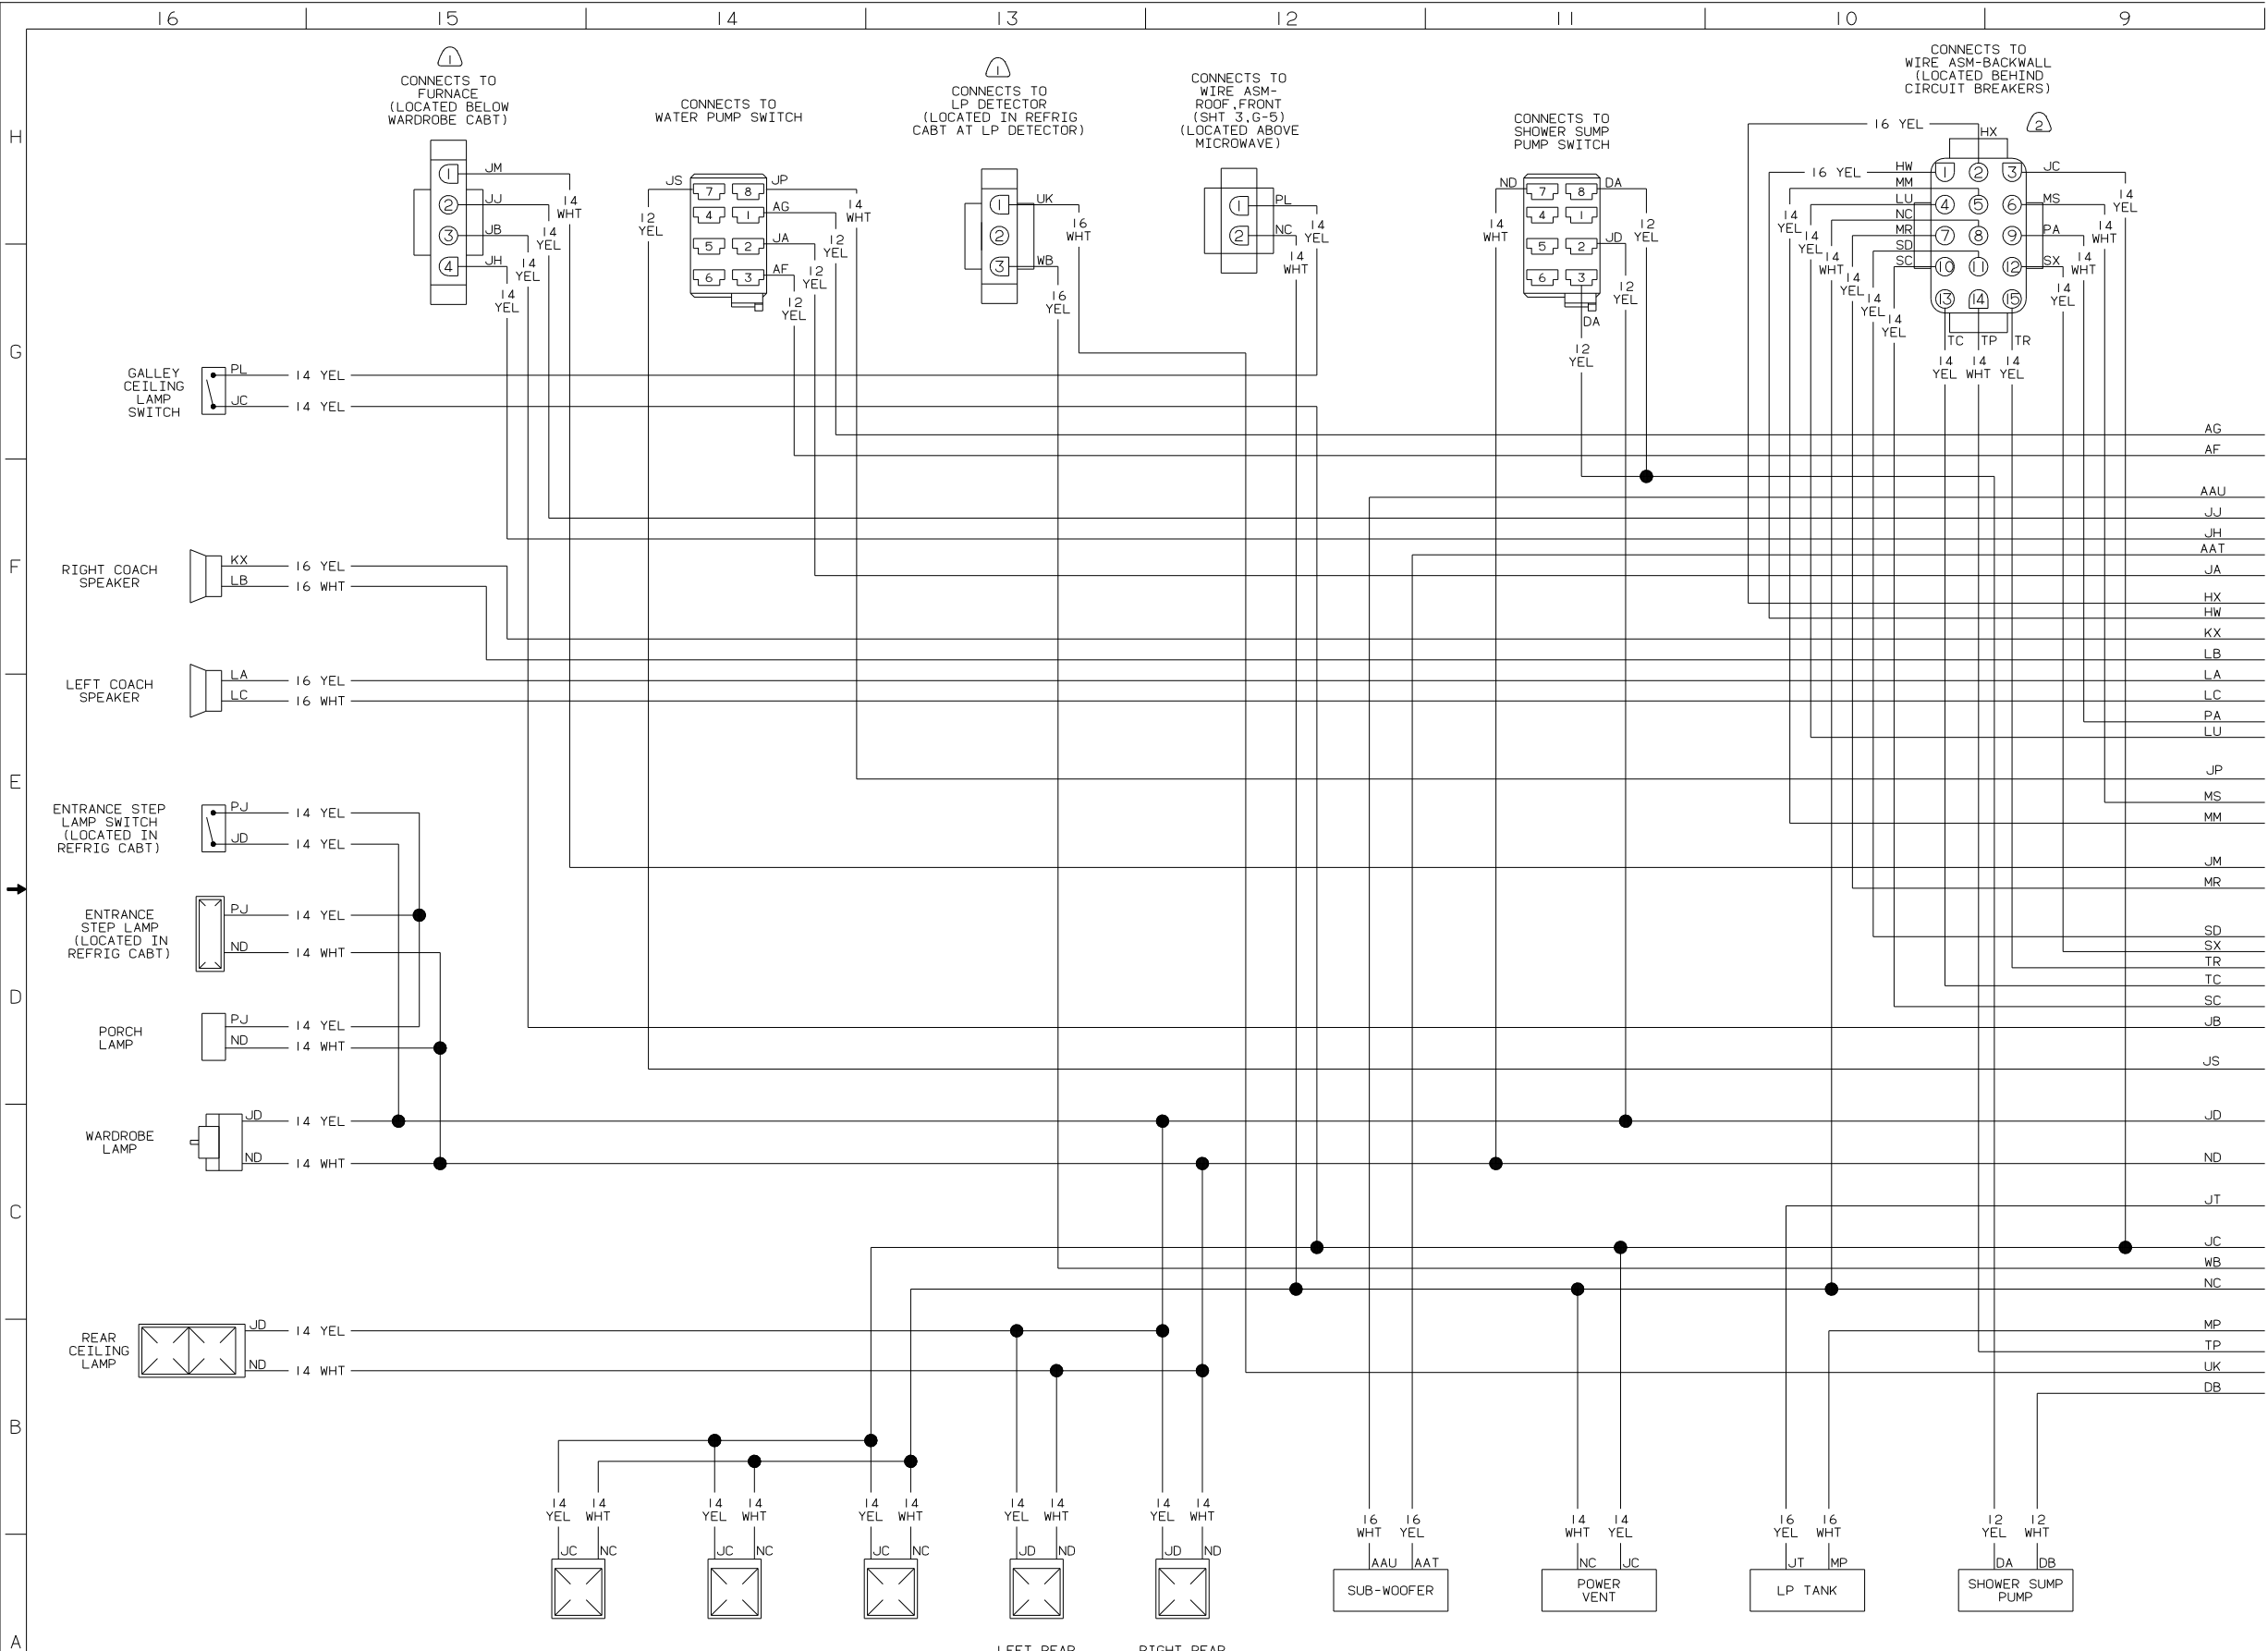
① CONNECTS TO FURNACE (LOCATED BELOW WARDROBE CABT)

CONNECTS TO WATER PUMP SWITCH

① CONNECTS TO LP DETECTOR (LOCATED IN REFRIG CABT AT LP DETECTOR)

CONNECTS TO WIRE ASM-ROOF FRONT (SHT. 3, G-5) (LOCATED ABOVE MICROWAVE)

CONNECTS TO SHOWER SUMP PUMP SWITCH

CONNECTS TO WIRE ASM-BACKWALL (LOCATED BEHIND CIRCUIT BREAKERS)
