WIRING DIAGRAM-COACH (WIRE ASM 122558)

110V WIRING
97 117RG

TITLE: WIRING DIAGRAM-BODY	
NO. OF SHEETS: 2	SHEET: 2 OF 2
REV. NO. 1	122557

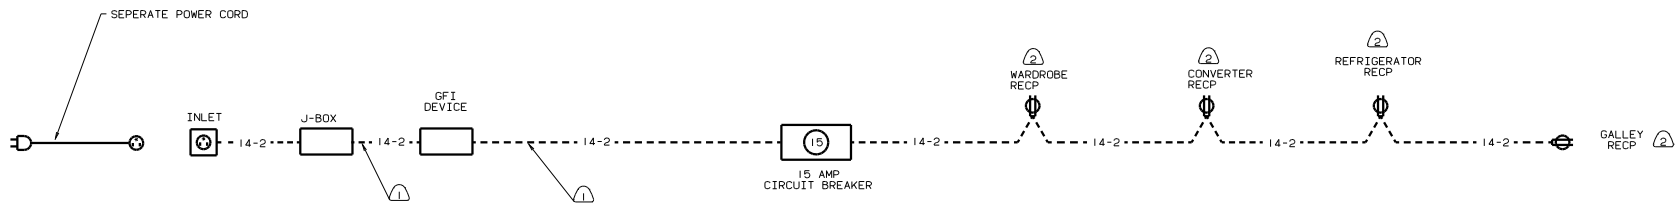
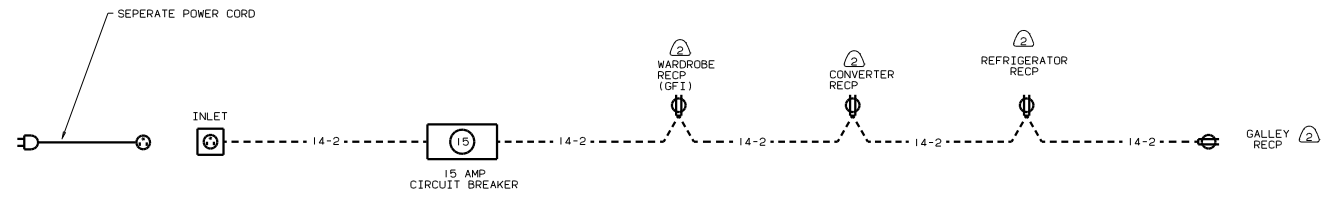
- (2) PROTECTED BY GROUND FAULT CIRCUIT INTERRUPTER.
- (1) VENDOR SUPPLIED WIRE.
